7.0 STORMWATER ISSUES AND OPPORTUNITIES

7.1 STORMWATER ISSUES

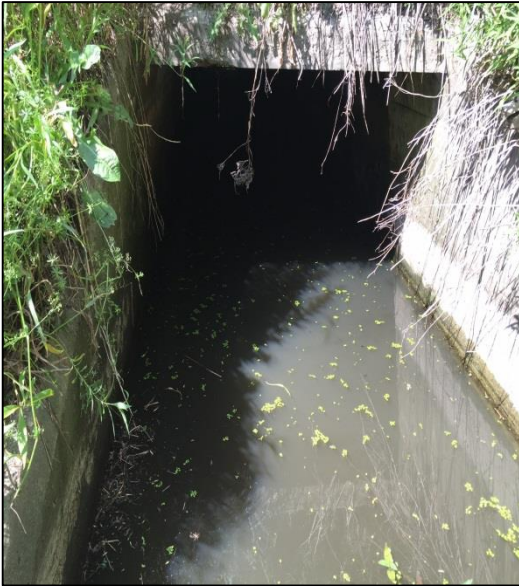
The hydraulic assessment results reveal that the Breslau Drain Structure BD-ST3 can convey up to the 25 year event. Woolwich Road South overtopping occurs at events greater than 25 years. The flood profiles show that the backwater effect at this culvert severely impacts flood elevations up to the Fountain Street structure located approximately 550 m upstream for events 50 years and greater.

BD-ST3 Structure Inlet

- Replacement of the undersized culvert on the Breslau Drain at Woolwich Street will significantly reduce upstream flood elevations for more severe flood events including the Regional Storm.

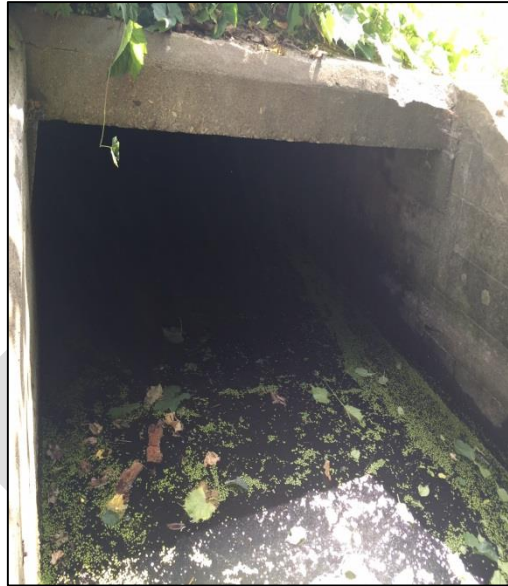
BD-ST3 Structure Outlet

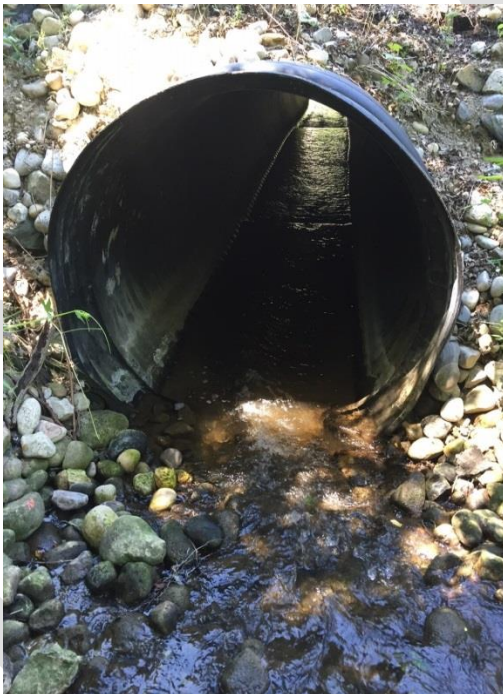
For the Randall Drain structure RD-ST1 the results show that the culvert can only convey 2 year flow prior to overtopping Riverbank Drive. The field observations show that recently some restoration work was completed at this crossing including a new CSP pipe and restoration at the culvert inlet and outlet (cemented rock protection). At the outlet the culvert is perched, which confirms the culvert is significantly undersized. It should be noted that this culvert was recently replaced. The culvert was intentionally not upsized in order to not increase frequent flood impacts to the downstream landowner.

RD-ST1 Structure Inlet

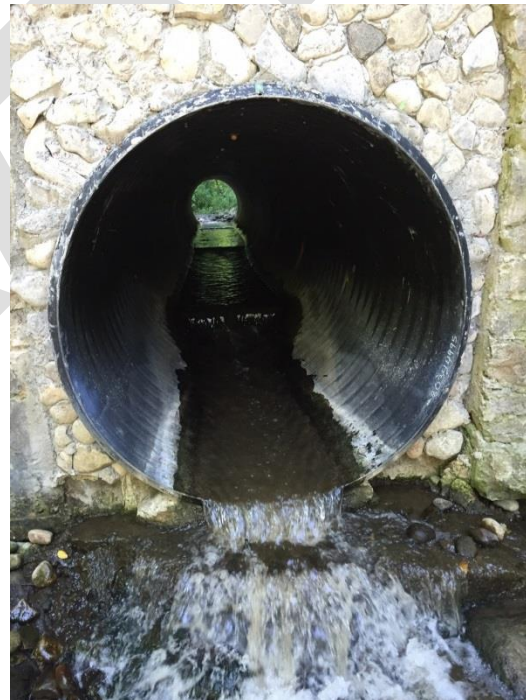
RD-ST1 Structure Outlet (Perched)
