Region of Waterloo

Balancing Environmental Protection & Transportation

The Laurel Creek Headwaters Environmentally Sensitive Landscape Case Study

January 2016

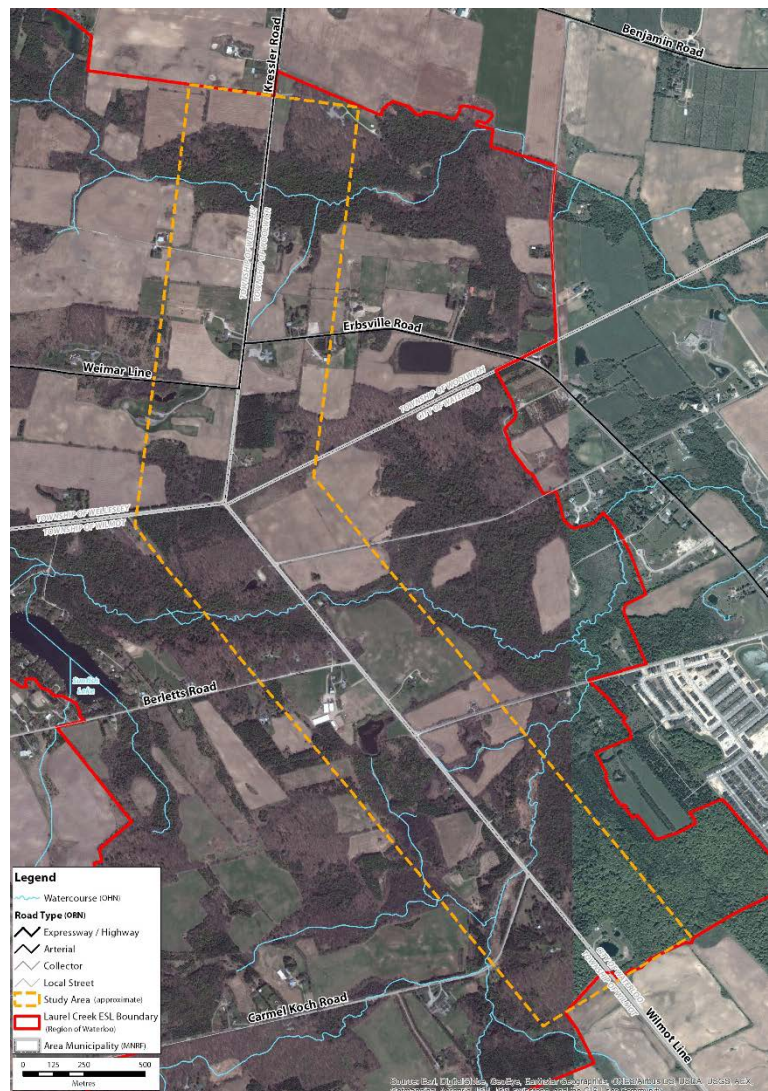
Figure 1: Case Study Area

The goal of this study is to provide recommendations on how best to balance ecological processes and sensitivities with transportation needs within all ESLs, using the Laurel Creek ESL as a case study. The Case Study area within the ESL is limited to the sections of Kressler Road and Wilmot Line that fall within the limits of the ESL boundaries and the adjacent natural

areas (Figure 1). Public consultation included Project Team meetings, a presentation to the Laurel Creek Headwaters ESL Public Liaison Committee, presentations to Area Municipal Councils, and two public open house meetings. In addition, the report for this study was circulated to the Laurel Creek Headwaters ESL Public Liaison Committee, the Grand River Conservation Authority and the Region's Ecological and Environmental Advisory Committee (EEAC) for review and comment.
